TECH NOTE

No. 001

Cessna Pilots Association™

Nose Wheel Shimmy

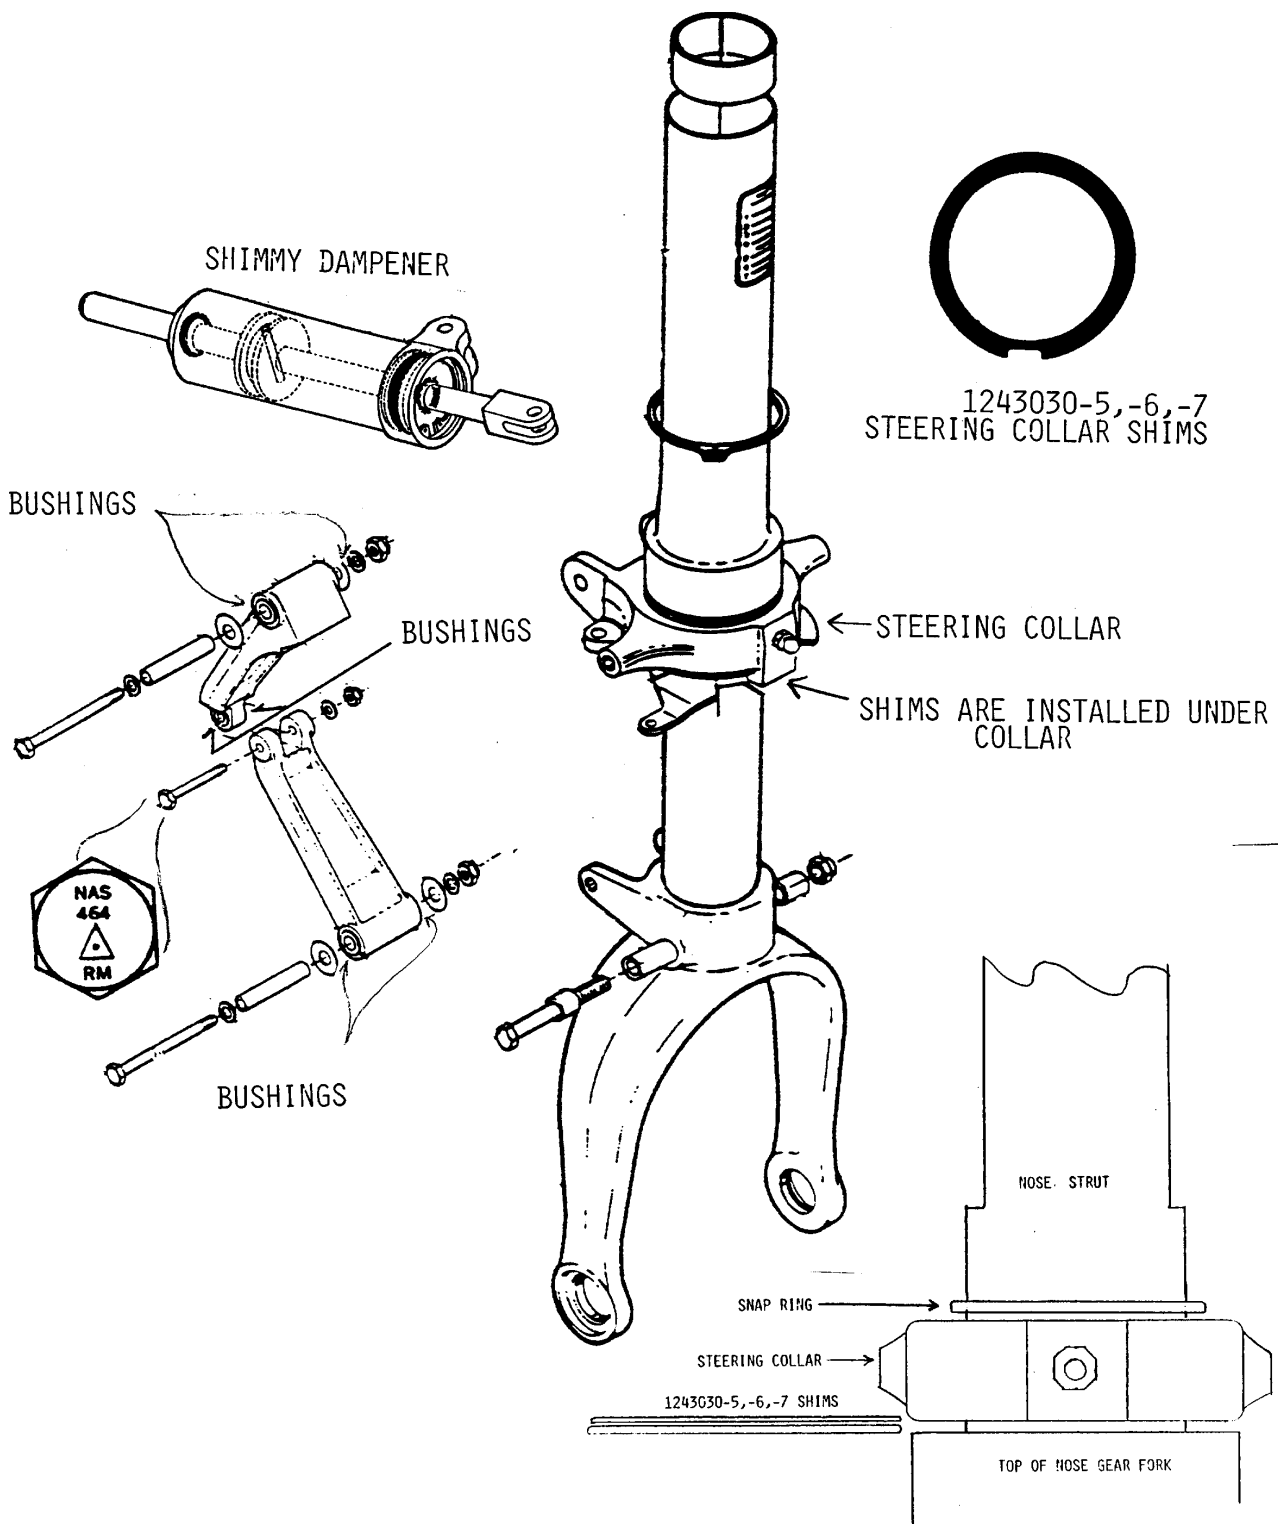
The shimmy dampener is a closed chamber full of hydraulic fluid. When shimmy occurs the motion is damped by hydraulic fluid being forced through a small hole in a moveable piston. Fluid leakage past the shaft and endcap seals, fluid leakage past the thermal relief valve O-ring in some models, and bent piston shafts can occur.

Also, the bolt holes at the shimmy dampener attach points should be checked for elongation. Any play at these points will cause a shimmy that can't be dampened. In CPA's experience, servicing the shimmy dampener to reduce shimmy without checking and remedying any defects in nose wheel balance, torque link play, and steering collar will be ineffectual.
